Case Study

Grease/Water Separator | Sapulpa, OK

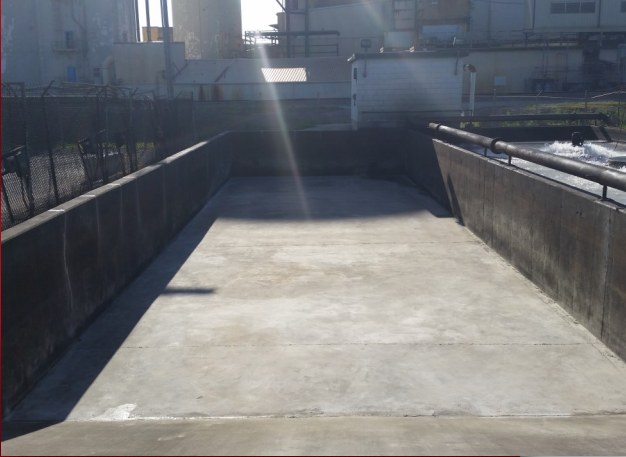
Install a flexible membrane liner in a concrete pit that is designed to separate grease from waste water at a large glass manufacturing facility.

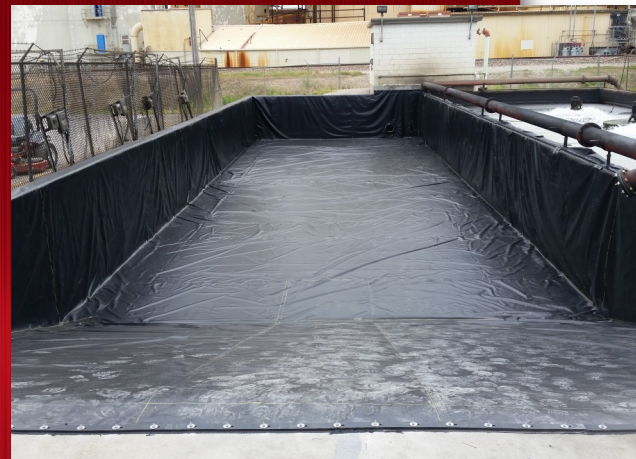
Having been in use for years, the pit's concrete was saturated with oil and grease. Due to this, an applied coating would not adhere properly. Furthermore, being located in an area subject to earthquakes, there were concerns about the integrity of the pit in the event of an earthquake. There were also doubts about the ability of a coating to bridge cracks that might occur in the concrete.
