Case Study

Leaking Water Pit | Medical Hospital, New York City

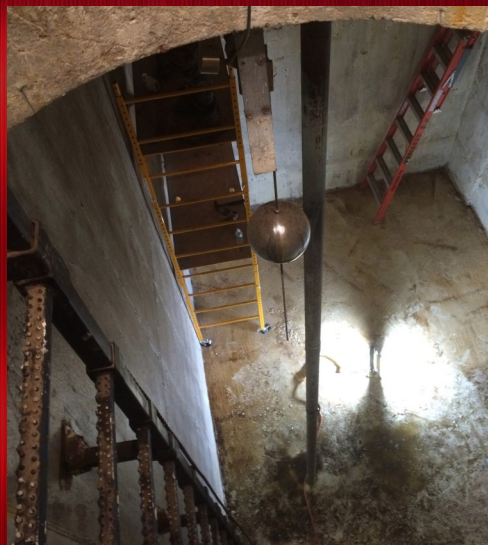
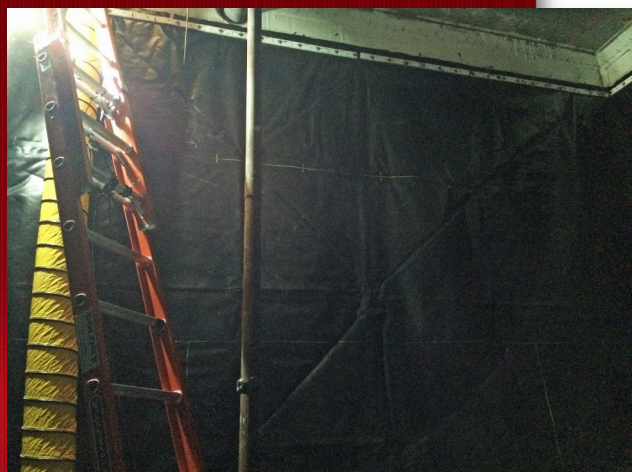
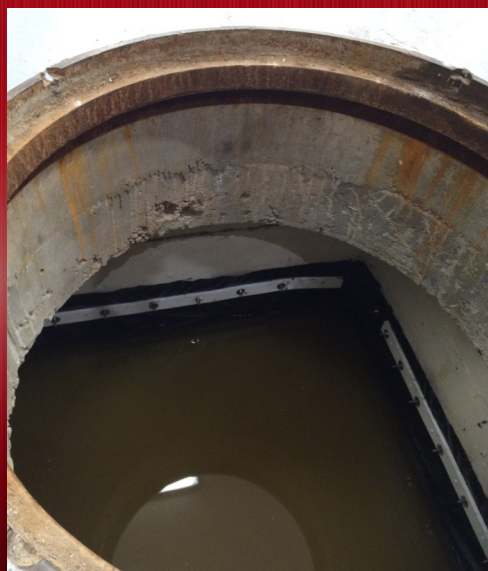
As part of an addition to a major NYC hospital, a pit was built to hold water for the fire suppressant system. The pit was designed with water stops, but the pit leaked into adjacent parts of the hospital. A water resistant coating was applied but it too failed. A second attempt at the applied coating also proved futile.

The architect for the job selected a flexible liner from Witt Lining Systems to line the pit. A Witt Liner isn't affected by the cracks in the concrete that the applied coating was unable to bridge in the previous attempts to repair the pit. A geotextile padding was installed on the pit walls and floors to protect the liner. The custom liner was fabricated in one piece and shipped to the job site for installation. The pipe penetration in the tank was handled on site by the installation company with a pipe boot supplied by Witt Lining Systems.

Installation of the padding and liner was completed over 3 days. Upon completion, the pit was returned to service. Field reports concluded that no further water was weeping into other rooms as was the case with the failed coating. The finished liner is expected to provide years of worry-free service in the pit.
