Case Study

Waste Water Settling Tank in a Government Facility
San Francisco, CA

Project Scope

Remedy a leaking in-ground waste water collection pit with the installation of a flexible PVC drop in liner.

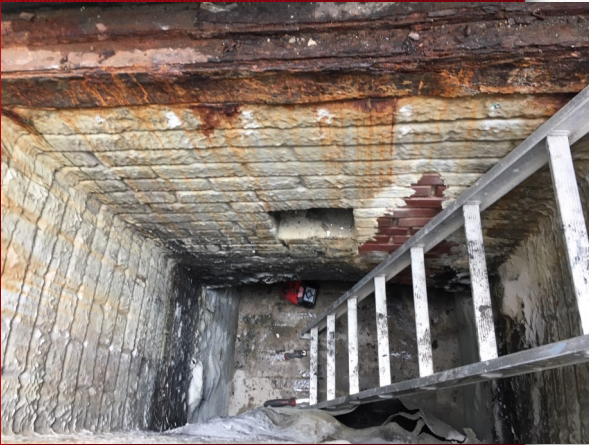
Built decades ago, the brick lined settling tank was showing signs of failure and needed to be upgraded to ensure liquid integrity. Limited space in the underground area made replacement impossible. Down time could only be a maximum 72 hours, making many lining and coating options unsuitable.

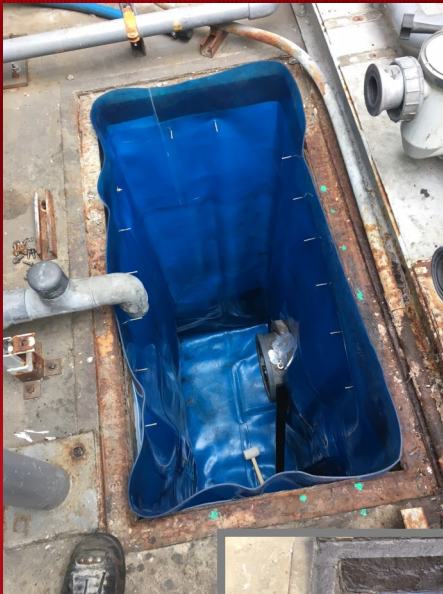
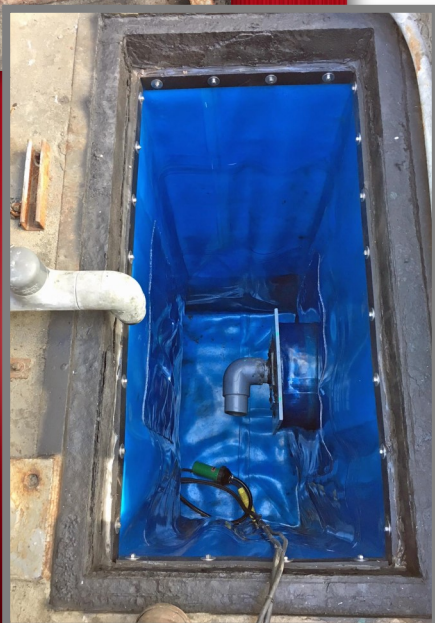
The liner was installed by H3 Services over a weekend. The flexibility of the liner allowed for large fabricated pieces to be folded into the limited work space and then assembled inside the pit. H3 Services field welded the pieces together and formed the liner around the baffle walls. With the liner installed and tested, the settling pit was returned into worry-free service.
