witt lining systems

# Technical Paper

## When Cheaper Is Not Less Expensive

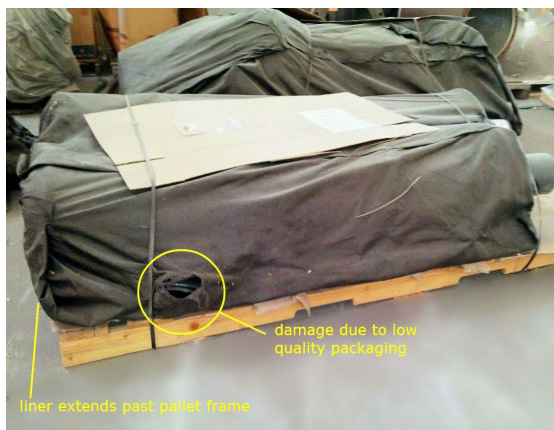
Packaging style of cheap liner.

**Liners should be packaged in a triple wall cardboard box constructed with adhesive** rather than staples that could damage the liner. Sharp objects can easily come in contact with the liner and tear or slice it.

**Large liners may even require a wooden crate to provide adequate protection during shipment.** Simply wrapping liners in a tarp and banding them to pallets leaves a high probability for damage and lost shipping documents.

Liners should not extend past the frame of the pallet. This could create serious damage to the liner from neighboring crates.

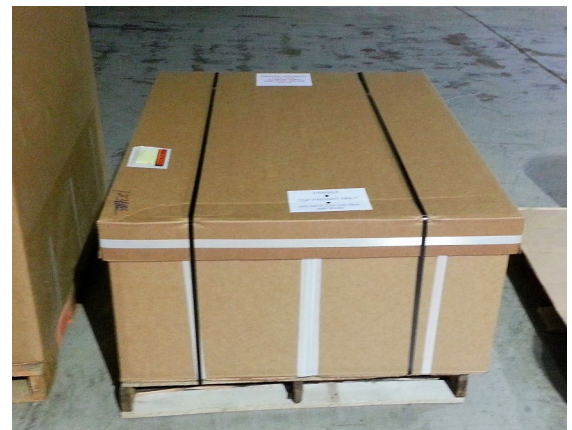
Packaging of a high quality Witt Liner.

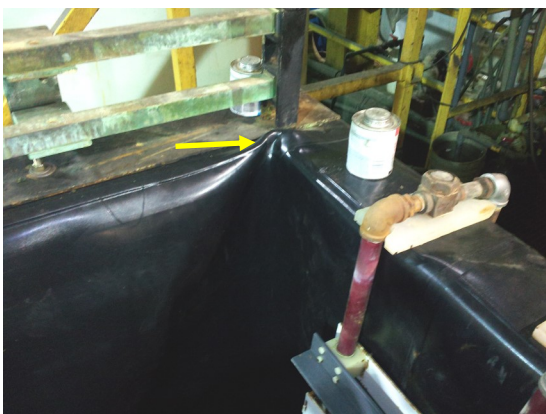
Pucker caused by uncreased corner

Liners manufactured without creases can cause the bottom of the liner to sit improperly on the bottom of the tank. When a liner gets caught on the sidewalls of the tank, even just one inch from the bottom, it forces the corners and sidewalls to push inward. This results in extra material bunching down the length of the liner making it appear too long. The result is that process equipment in the tank may interfere with the liner which can have a devastating effect on the liner's service life.

**Proper creasing eliminates costly puckers or sharp wrinkles.** Areas of a liner that wrinkle or don't lay flat when pressure is applied cause a stress point on the material. This is likely to result in a stress fracture at that point of the liner well before the rest of the material has surpassed its service life.

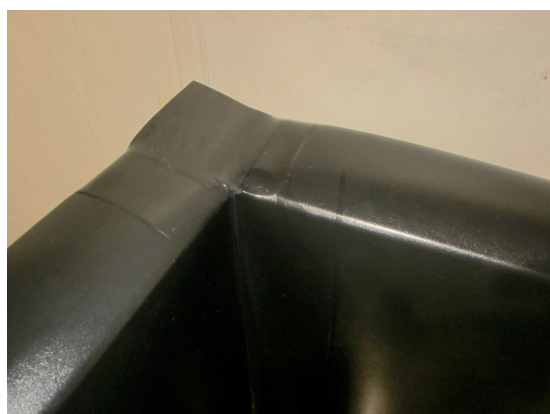
Perfectly formed corner with creases

**In order to fit properly, liners must have dielectric creases on vertical and horizontal corners.**

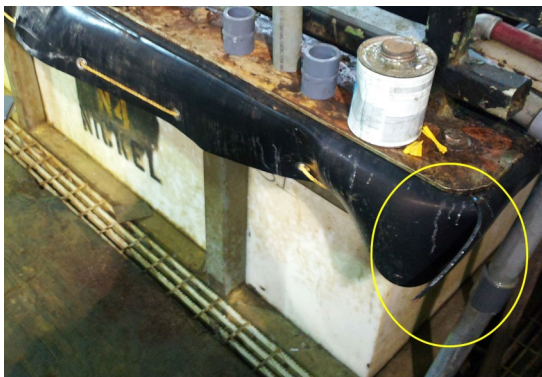
Liner without fabricated corners must be cut to fit.

Without a fabricated top corner the liner has to be split to allow the material to come across the top of the flange or top wall. This can cause the liner to not sit properly along the top corner of the sub structure and will greatly affect the quality of the fit.

Without fully formed top corners, the use of stainless steel Wittclips™ for fastening is very difficult. Instead, a drawstring rope may need to be employed. The rope will not lock the liner to the top flange of the tank. Material will then slip inside of the tank, interfering with process equipment which can damage the liner.

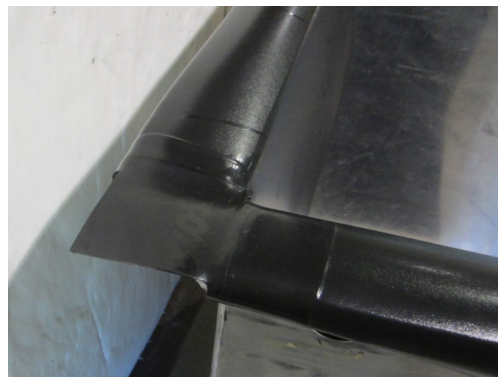
Fabricated top corner secured with Wittclips™.

**Quality fabrication techniques also involve fabricating a full top corner** when the liner is intended to come across a flange or horizontal edge. Where the sidewalls meet, an additional corner should be welded into the liner allowing it to flare out across the top of the lined structure, also covering that section.

Properly formed top corners allow for the use of Wittclips™ to securely fasten the liner into place, holding the liner securely against the sidewalls of the tank where it will not interfere or become damaged by process equipment or parts.
